# Assessment of Road Safety Audit on State Highway

1Mohammed Sawood Ali, 2Mohammed Abubakar, 3Syed Omer, 4Ma Kazeem, 5Mrs. Taheseen Sultana

Department of Civil Engineering, Deccan College of Engineering and Technology, Darussalam, Hyderabad, Telangana

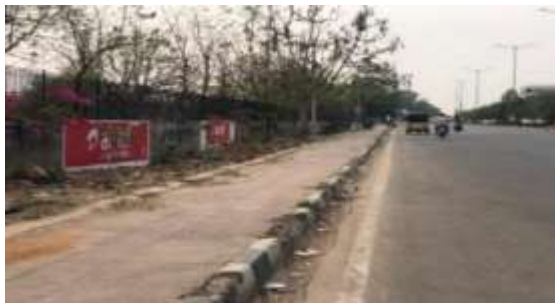
**Figure 4.1: At chainage 0.800km,**

footpath of 3km length and width 1.3m is provided for pedestrians.

According to IRC:103-2012, Footpaths in residential areas require a minimum clear width of 1.8 m.

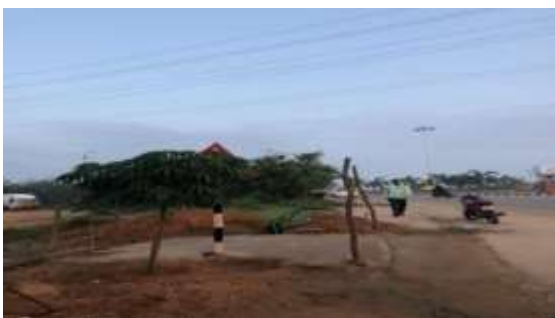
**Figure 4.3: At chainage 1.900 km,**

Roundabout ahead sign is blocked by vegetation beside the road. And poor visibility signs at CH:3.600 km, 6.800 km, 9.000 km.

IRC: 67-2012 shall be referred as code of practice for road signs and should be erected not less than 60 cm away from the edge of kerb in the case of kerbed road and at a distance of 2-3 m from the carriageway edge in case of un kerbed roads and all signs shall be inspected at least twice a year.

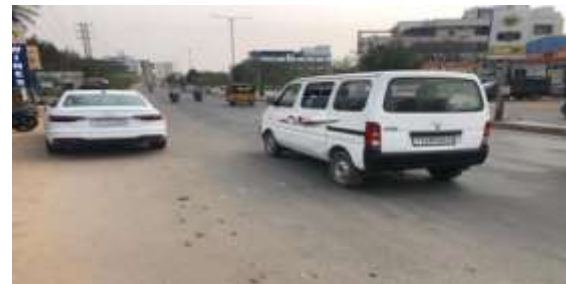
**Figure 4.4: At chainage 2.300Km,**

there is no shoulder for car parking. The vehicles are parked on side of a road. Adequate enforcement shall be applied to restrict parking in no-parking zones.

IRC: SP: 12-1973 provide tentative recommendations on the provision of Parking Space for urban Areas. Moreover IRC: 67-2012 provide guideline and standards for signs necessary for on-street and parking lots. IRC: 35-1997 recommends various road markings to distinguish parking lot from service lane and park a vehicle is allotted space only.

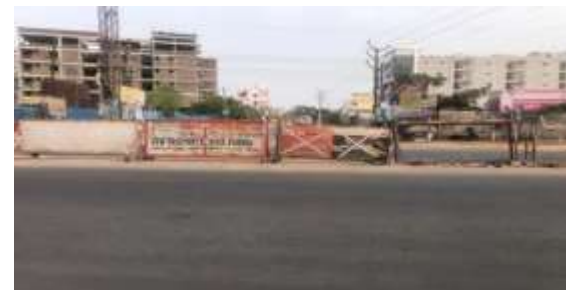
**Figure 4.5: At chainage 2.600 Km,**  
Barricades provided are damaged. Need to be replaced

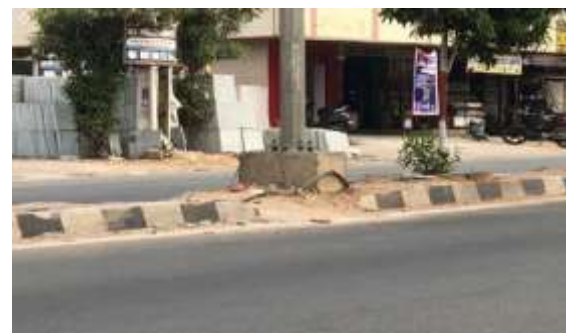
**Figure 4.6 At chainage 3.000 Km,**

Unauthorized opening in the median for illegal movement of two wheelers leading to unsafety.

2. It also observed that the moderately moving vehicular traffic is generating traffic problems for the fastmoving vehicular traffic.
3. All the unauthorized gap-in-median should be closed.

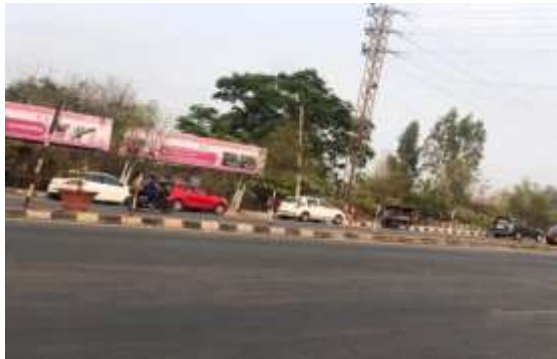
**Figure 4.7 At chainage 7.400 Km,**  
Unauthorized parking by group of vehicles along the road.  
Temple located on side of road having less width.

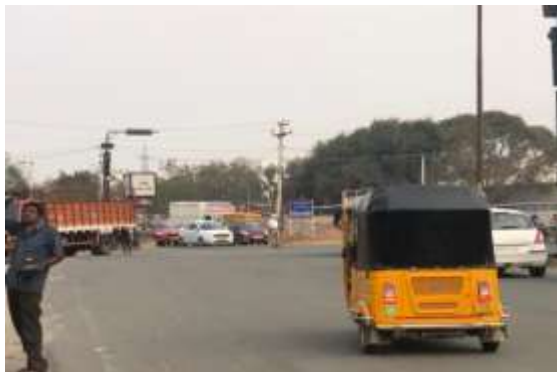
**Figure 4.8: Chainage 14.700 Km**

Have a Junction without working traffic signal.  
Junction with considerable amount of traffic without a working traffic signal is a major spot for accidents.

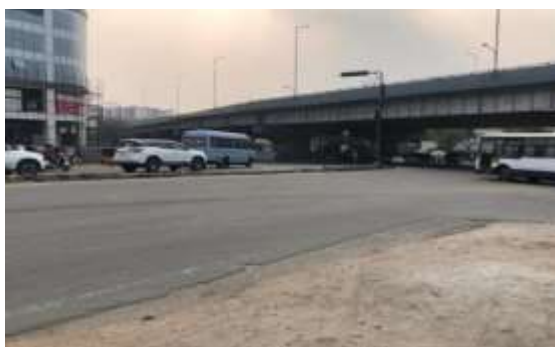
**Figure 4.9 Chainage (15.000 Km)**

Sagar Ring Road junction which is at the end of Stretch, major junction without proper functioning

of traffic signals. The traffic from flyover converging in to Junction without a traffic signal is a major spot for accidents happening over there.

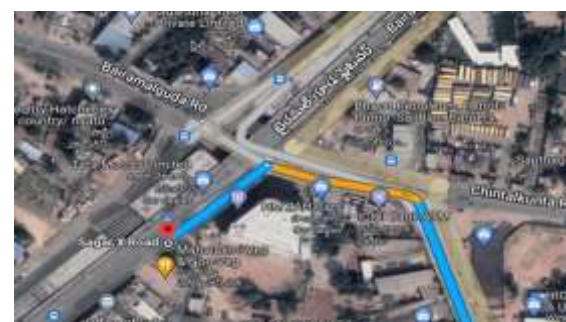
**Figure 4.11: Sagar Ring Road Junction**

The entire section of study between Manneguda to Sagar ringroad is unsafe from safety point of view. The main reason is local traffic has direct access to the State Highway, which results in congestion and accidents. Analysis of accident data within the study area showed that about 38 accidents occurred on the study stretch in the year 2020-21. Maximum accidents were occurred at (Manneguda Junction, Sagar ring road Junction, Injapur lake, turkayamjal x road, Gurramguda). The identified black spots were investigated in detail to assess the cause of accidents and suggest the remedial measures to minimize the accidents.
